Caltex Energy Inc.
Hydraulic Fracturing Incident
16-27-068-10W6M
September 22, 2011

ERCB Investigation Report

December 20, 2012

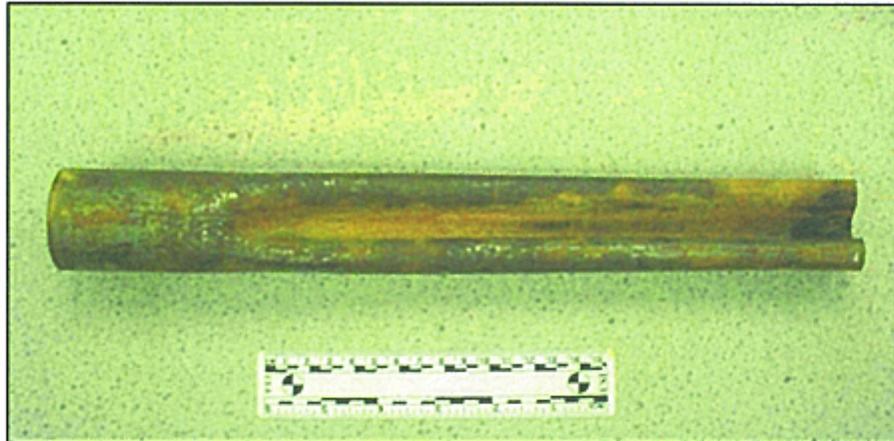
While stripping the coiled tubing and perforating gun from the well, the coiled tubing was found to be collapsed from approximately 75 m to 27 m above the bottomhole assembly (BHA). The collapse was not recognized as affecting the perforation depth. The cause for the collapsed coiled tubing was not explained by the field personnel, nor was the mechanism for failure confirmed after the event. Consequently, the relationship of the coiled tubing collapse to the off-depth perforations has not been adequately explained. Appendix B: Collapsed Coiled Tubing contains pictures of the failed coiled tubing extracted from the failure analysis report done by NOV Quality Tubing.

Figure 1: As recieved - Overall view of the sample (deformation is on the right).

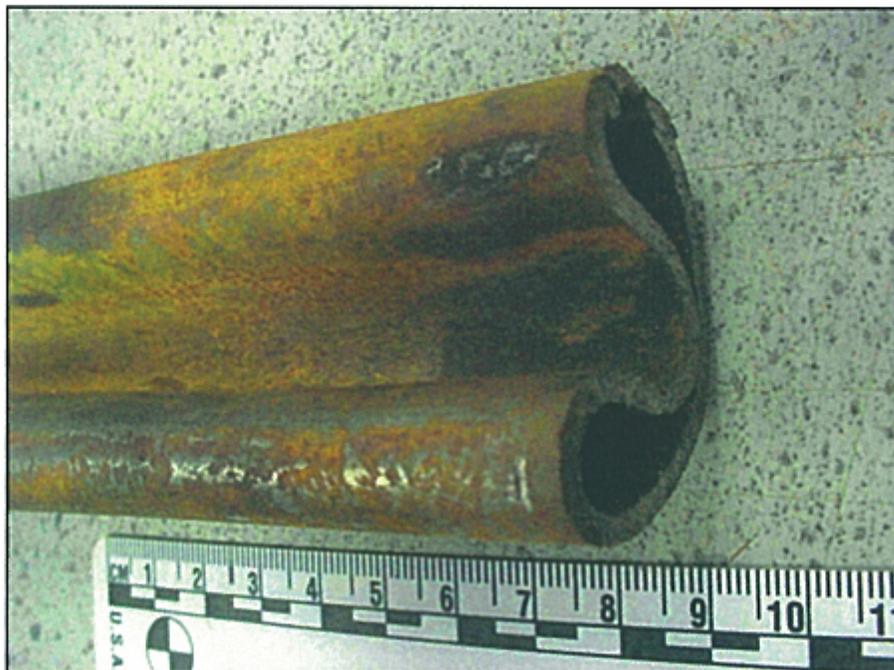
The coiled tubing collapse was recognized when the coil could not be stripped through the injector head. NOV Quality Tubing determined that the coiled tubing would have required an external pressure of 2230 psi (15 400 kPa) to collapse the coil. Crew concluded the collapse was due either to overpressure of the annulus or a material fault with the coil. The collapse was likely the cause of the premature firing of the perforating gun

NOV Quality Tubing concluded the most likely cause of the coil damage was collapse due to external pressure. Mechanical testing of the damaged section of coil did not identify off-specification materials. Consequently, an annulus pressure almost double the planned pressure of 8000 kPa was likely applied to the coil tubing to cause it to collapse. As indicated in Section 2.2.1, the highest pressure observed and reported was 10 000 kPa. Consequently, confirmation of the collapse pressure is not available.

Figure 2: As recieved – Orthogonal view of the deformed end of the supplied sample (right side of Figure 1). The deformation is most likely the result of collapse. Scale minor dimension is in mm.

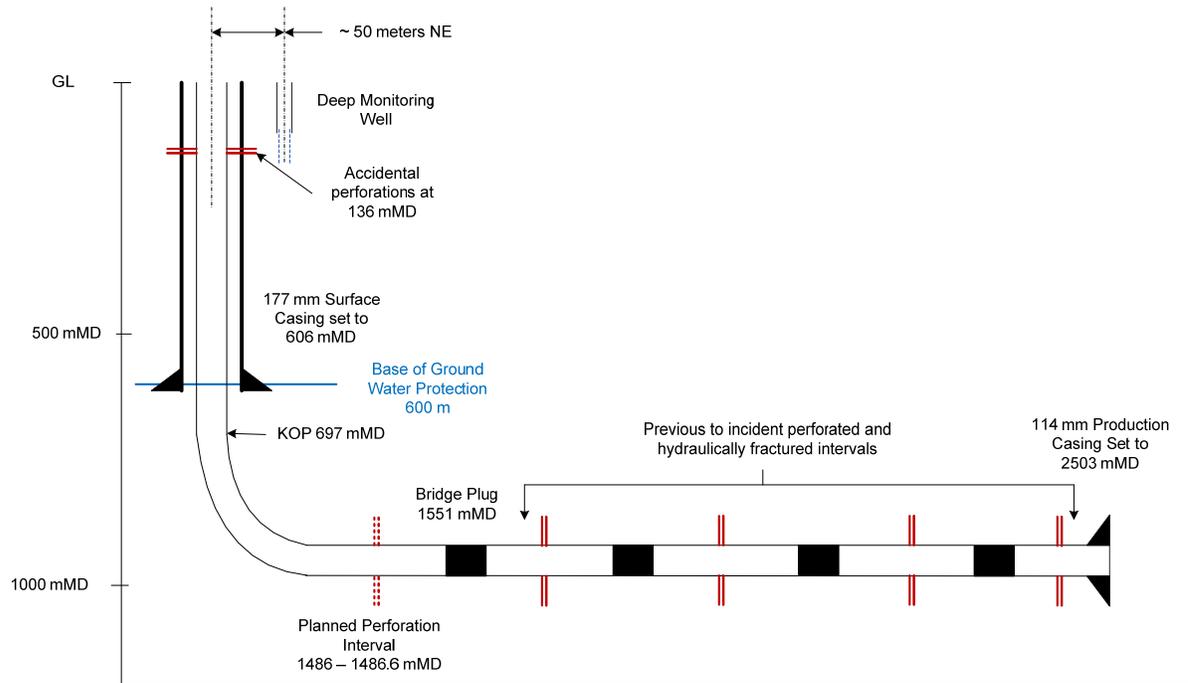
Caltex HZ ELM 14-34-068-10 W6M
Well Cross-Section Schematic

Combustible gas, assumed to be propane, was detected at surface on the deeper well using a combustible gas detection meter (LEL). However, the gelled propane chemicals were not identified in the fluid samples collected from this well. Pump test results from the deep monitoring well showed that the hydraulic properties of the fractured zone were too low to meet ESRD's definition of a DUA. Appendix C: Well Cross-Section Schematic depicts the horizontal well in relation to the off-depth perforations and the deep monitoring well
