Canadian Natural Resources Limited
Well Blowout

09-12-75-12W6M

February 24, 2010

ERCB Investigation Report

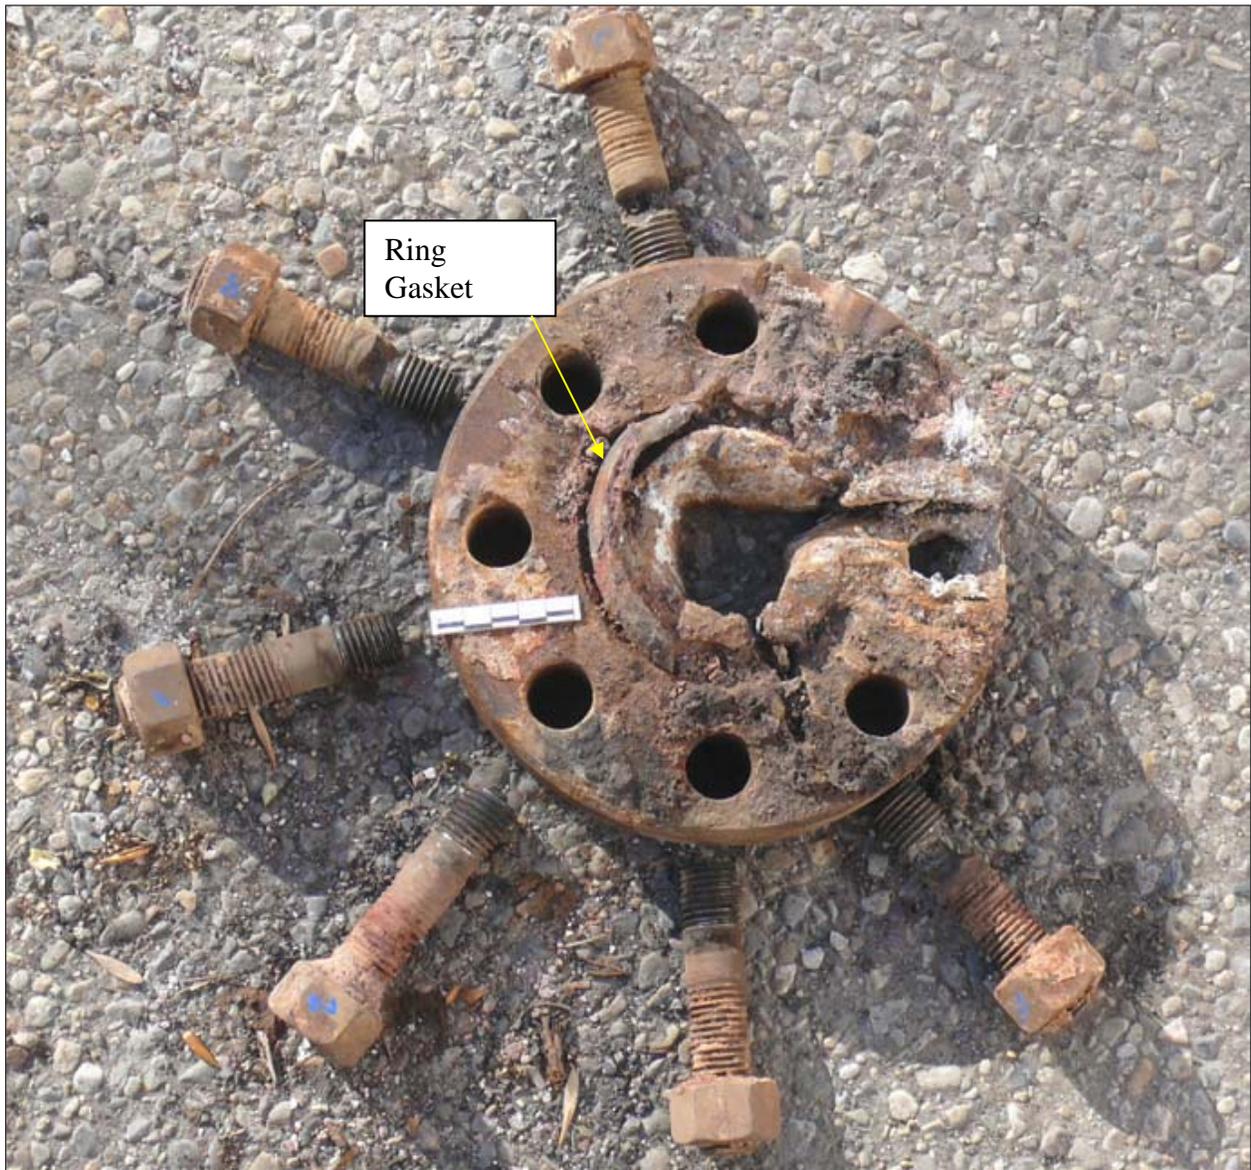
Canadian Natural retained Acuren Group Inc. (Acuren)⁵ to perform an analysis of a sample of the surface casing and the BOP equipment. Acuren prepared three reports regarding its analysis of the components. The reports conclude that there was extensive erosion of the casing bowl blind flange caused by an extended period of leakage of high pressure fluids. Acuren was unable to determine what caused the initial leak in the casing bowl blind flange.

The ERCB has concluded that the blowout and resulting fire were caused by drilling into an abnormally high pressure formation and the subsequent failure of the casing bowl blind flange. The ERCB accepts the findings of Acuren.

Figure 2. Exposed blind flange

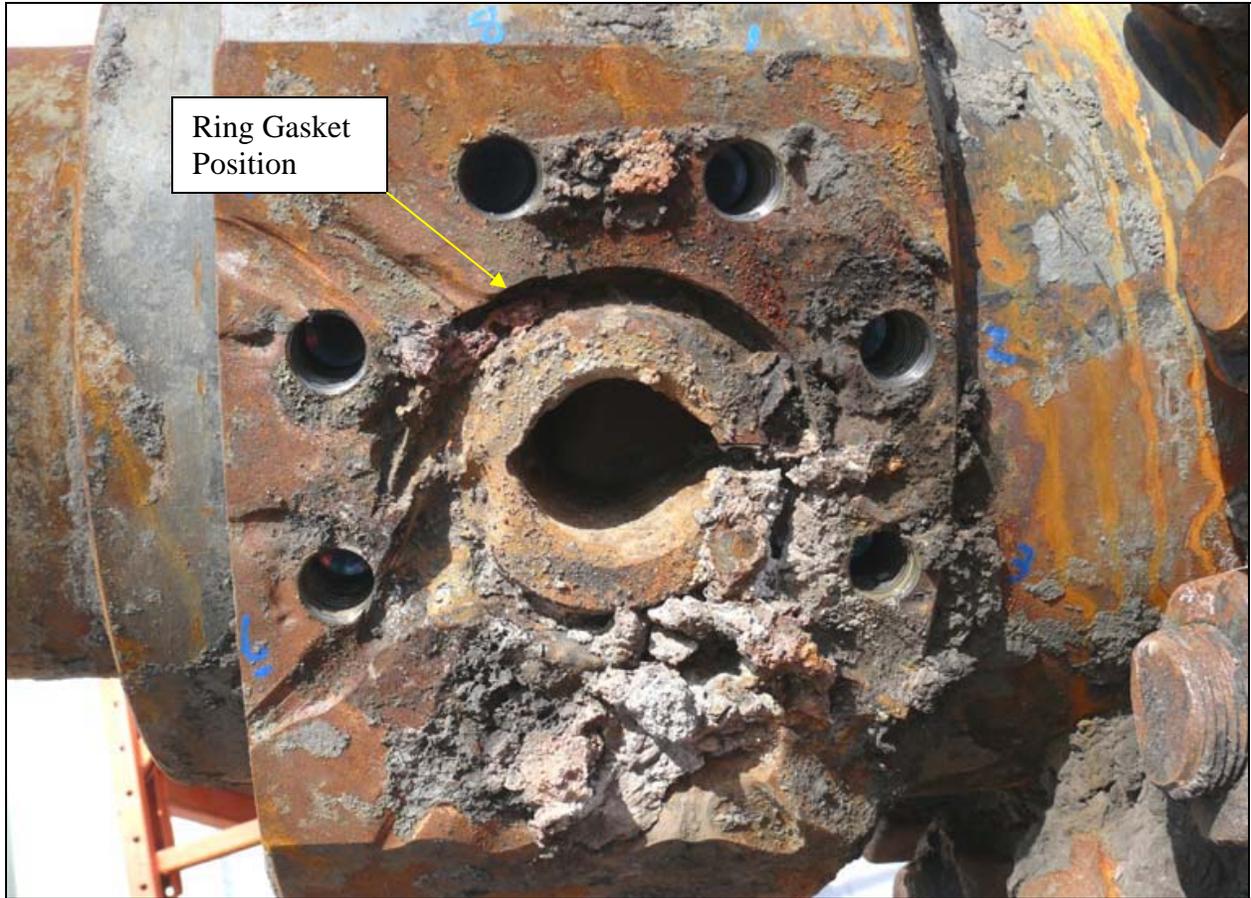
Figure 3. Casing bowl sealing faces
